Sandburg Garage Indoor Air Quality Survey

Evaluation of carbon monoxide (CO) and general hydrocarbon levels in the Sandburg Parking Garage during move-in day, September 2, 2000.

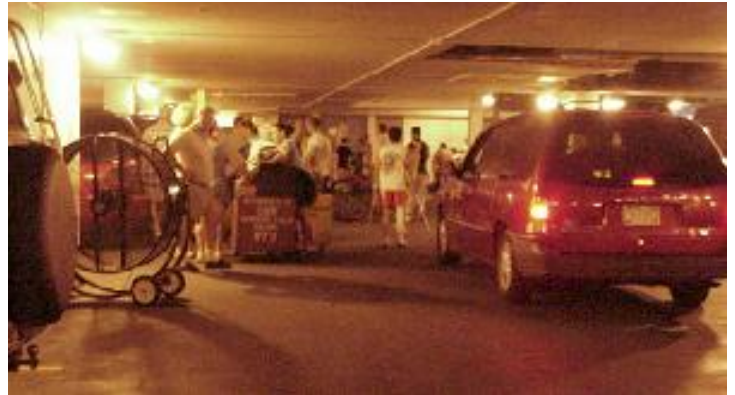
Placement of fan (left) near north tower staging area.

- The time-weighted average CO level near the north tower staging area (CB1R) was 6 ppm; the average general hydrocarbon level was 3 ppm.
- Dosimeter Tube Results:
 - 5 ppm near fan in southeast corner (CB1T)
 - 6 ppm near southwest corner (CB1S)
 - 4 ppm near ramp to lower level
 - 9 ppm near north tower parking meter (CB1R)
- Peak reading with MSA Passport was 159 ppm, near north staging area during heavy traffic.

- Exhaust values dropped significantly when a fan was relocated near the north staging area (see [graph](#)). This helped to dilute the exhaust, as well as providing some cooling-effect to those waiting in line. For future move-in days, we recommend placement of the fans in the interior spaces opposed to along the perimeter areas. Optimization of dilution of the exhaust may largely be due to trial and error.
