APPLICATION NOTE

INSTALLATION OF OPTICAL FIBER THERMOMETERS FOR IN-CYLINDER MEASUREMENTS

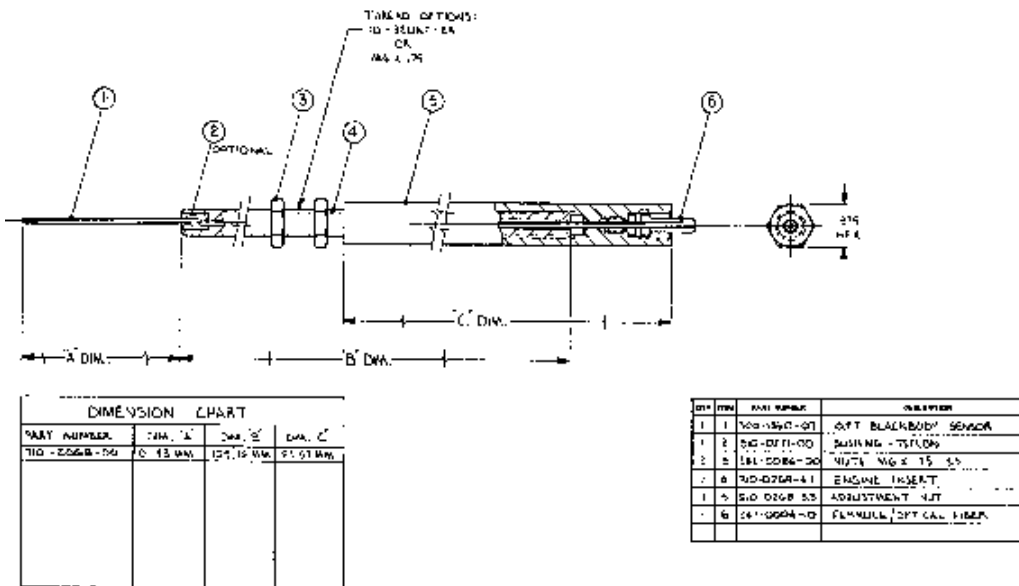
Figure 1: Standard OFT Engine Insert and Sensor

Optical Fiber Thermometer's (OFT's) have been installed in the cylinder heads of General Motors, Chrysler and Toyota production engines for dynamometer, chassis dynamometer and road testing. Cylinder head modifications are straightforward and can be completed within a day. The cylinder head is removed, sensor locations are determined and the cylinder head is drilled and tapped to accept a 10/32 English thread or M6x0.75 metric thread. Stainless steel inserts are installed and ground to conform to the engine cylinder contour (Figures 1 and 2). The hole in the engine insert through which the sensor is inserted into the cylinder is then polished with diamond paste and a 0.050" diameter wire to eliminate rough edges which can cause fracture of the sensor at the engine wall. Engine inserts can penetrate water passages using standard automotive engine sealants. Once the engine insert is installed and cylinder head dimensions are recorded the engine is reassembled. Sensors are then installed and located using the insert adjusting nut. (Detail 5 in Figure 1.)

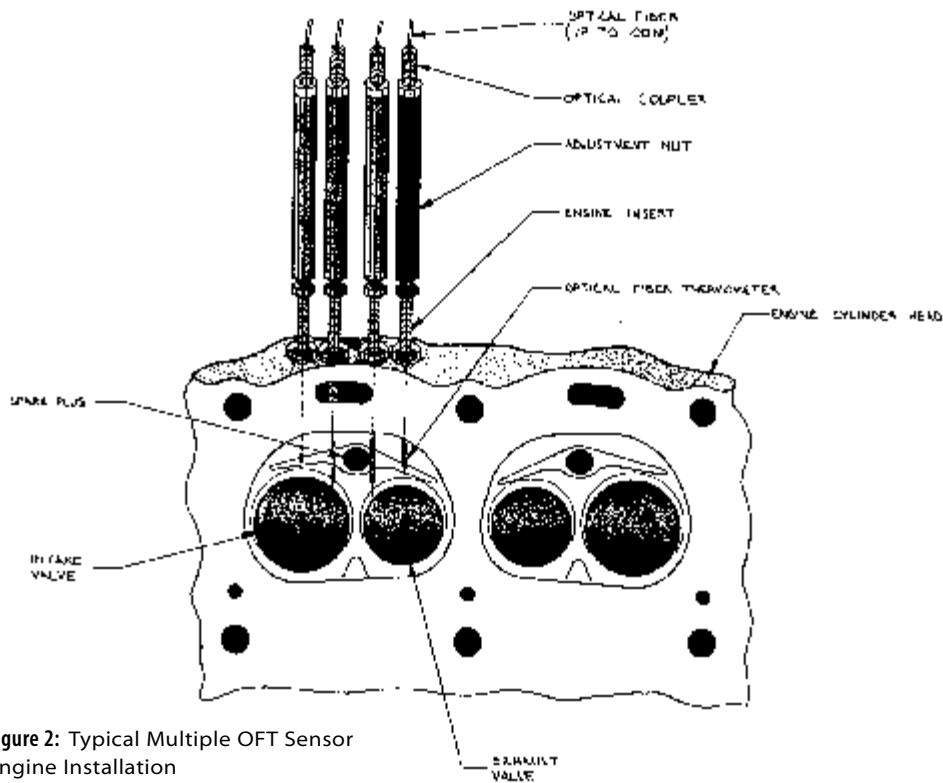
Figure 2: Typical Multiple OFT Sensor Engine Installation

Properly installed, the sensors exhibit unusual durability in the cylinder environment. For example, no sensor failures occurred during three days of dynamometer testing with the four OFT sensors array shown in Figure 2. during six months of road testing around two with engine speeds to 4500 rpm, the average lifetime of the sensors has been over one thousand miles. It has been found that sensors are damaged during road testing due to the ingestion of particles from the roadway. Additional data is necessary to determine the actual sensor lifetime for all engine operating conditions in the test stand or on the road.
